Analysis of the Failures in Power Transformers

Mehmet Zile*

Department of Information Systems and Information Technology, Erdemli Applied Technology and Business School, Mersin University, Turkey

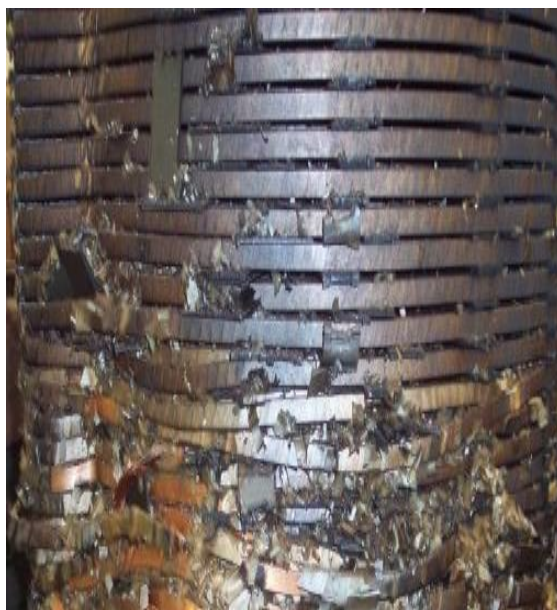
The life of the power transformers is 25 to 30 years according to their design. In practice, the life of a power transformer can be extended up to 50 years with appropriate maintenance. Due to the problems related to the manufacturing process in the power transformers, they fail in the first five years of operation or in life periods after twenty years depending on the maintenance and controls applied in the operation. As the transformers age, the risk of failure increases with the weakening of the material. Insulation levels may decrease to a level that cannot withstand faults such as short-circuit faults in the system or transient overvoltages. In the inspections carried out at the substations as seen in Fig. 1, a power transformer without preventive maintenance has exploded due to the deterioration of the insulation paper, and it shows a transformer that has suffered a disaster.

Figure 1. Power transformer exploded without preventive maintenance

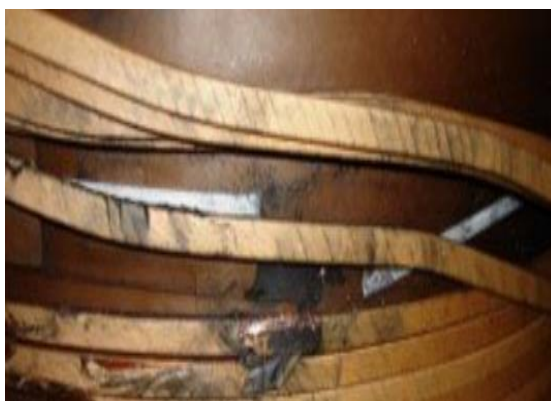
Figure 2. A short-circuit fault in the windings due to the tension and radial forces

The winding ratio was examined and the auxiliary isolation and damage point was determined. Power factor was examined and main isolation was controlled. The winding DC resistance was examined to determine the auxiliary isolation and damage point. Dielectric strength of oil was investigated and the damage point was determined. Warning signals, low voltage impulses, impedance and frequency response analysis were examined and mechanical damage, damage detection and auxiliary isolation control were provided. Induction voltage test is examined and auxiliary isolation control is provided. The winding resistance measurements ensure that a proper connection is made. If there is an open-circuit condition or a high-resistance connection in parallel conductor windings, the detection is provided. This test is applied to determine the mechanical movement of the windings as a result of the low-voltage impulse test, short-circuit-test. Partial discharge with induced voltage test is determined in isolation. With the high potential test, the basic pressures of the major insulation are determined. As seen in Fig. 2 in

the power transformer windings in transformer centers, the transformer coils result in a short circuit due to the tension and radial forces.

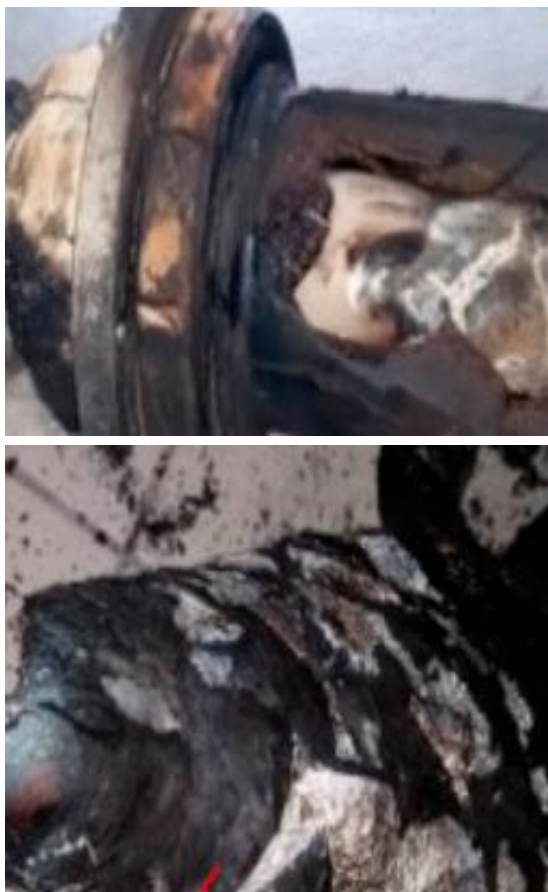
White ash, burning housing ashes and solid remains from the burnt bushing are given in Fig. 3.

Figure 3. White ash, burning housing ashes and solid remains from the burnt bushing

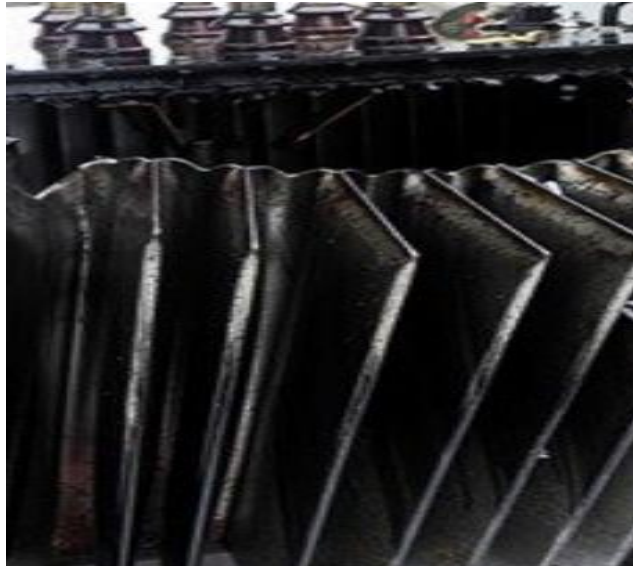
formation are investigated. For this reason, the gas values are recalculated by removing the previous values from the current gas values and reinterpreting according to the new situation. The internal inspection will determine the fault location as guaranteed and determine the damage size. A low oil level causes contamination to spread, the core and the suffer into the core and the coils. If there is contamination or dirt on the surface of the oil, this pollution must be disposed of. In order to show this situation transformer tank fault is given in Fig. 4.

Figure 4. Transformer tank fault

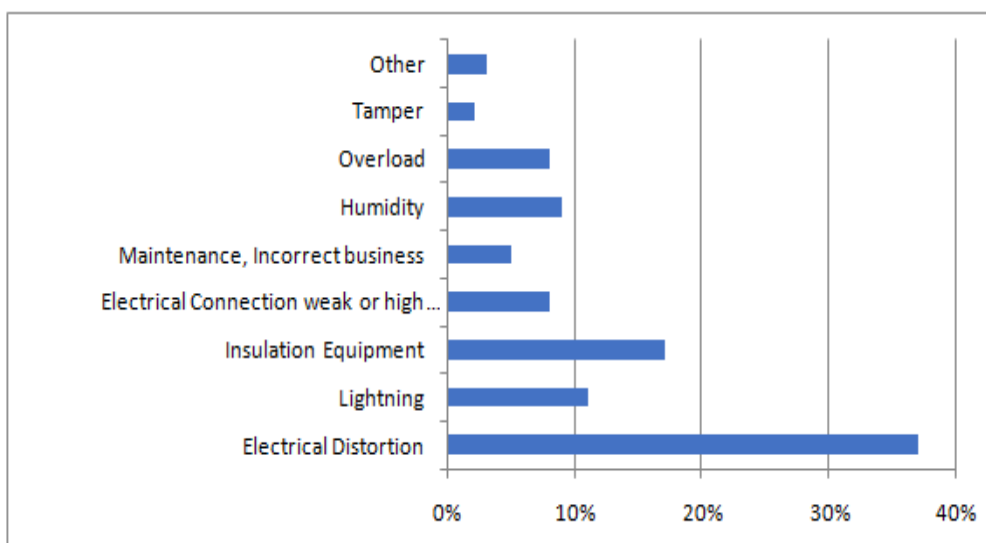
Figure 5. The failure statistics of the power transformers in Erdemli district

It has been determined that 37% of the malfunctions in Erdemli District and power substations are caused by electrical disturbances. It was determined that the transformers failed with the lightning strike. In this type of faults, the suitability of the transformer's insulation resistance to the surge arrester puncture voltage should be checked by isolation coordination. In the examinations made; It is understood that lightning, overexcitation, lightning, switching pulse voltage, winding resonance, sipir-sipir short circuit, short circuit of core layers, coil-coil short circuit, partial discharge, isolation puncture, static electricity in the oil and jumps all cause malfunctions. Fault type statistics of the power transformers in Erdemli district are obtained as in Fig. 6.

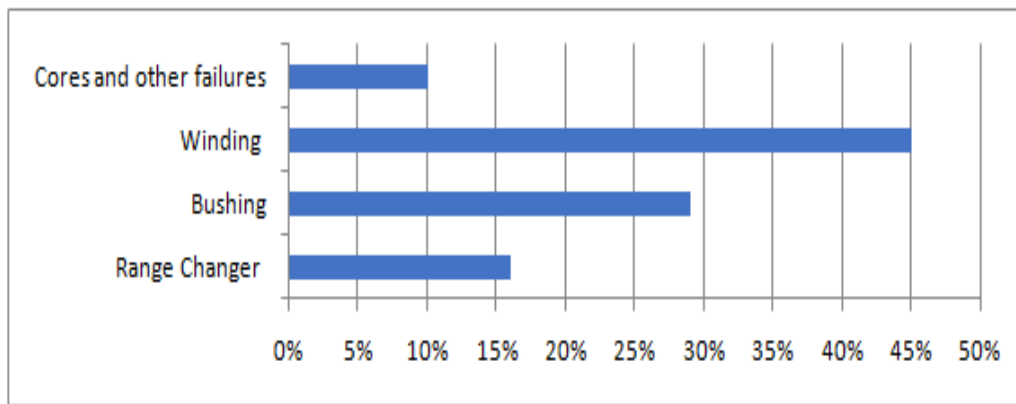
Figure 6. The fault type statistics of the power transformers in Erdemli district

It has been determined that 45% of the failures in the Erdemli District, power substations are winding failures. These malfunctions; It has been understood that there is short circuit between the windings, short circuit between the windings, winding breaks, winding combustion and cooling systems failures. In the examinations made, it is understood that the reason for this malfunction is due to the fact that power transformers are used in excessive load. At the same time, it has been understood that transformers are not protected against lightning and other atmospheric external effects, there are production defects in the windings used, and deteriorations in the insulating materials used due to excessive moisture.
